Webinar: Avoid Costly Problems

Assessing and Restoring Complex Building Envelope Systems

Case Study at White Cliffs Condo II Glenn Grassi

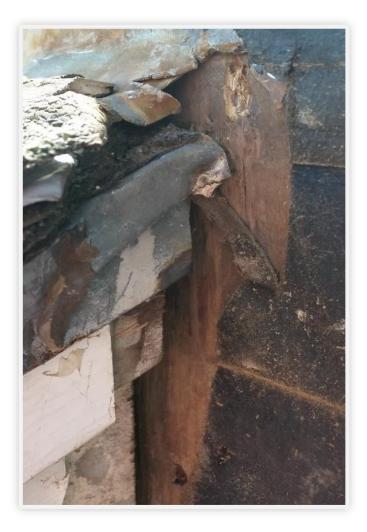
Interior ceiling and wall stains

- Poor quality
 - Roofing had no membrane or step flashing integrated with siding
 - Windows were not properly sized to the rough openings
 - Windows were not properly sealed or insulated
 - Deck attachments were not properly sealed and waterproofed

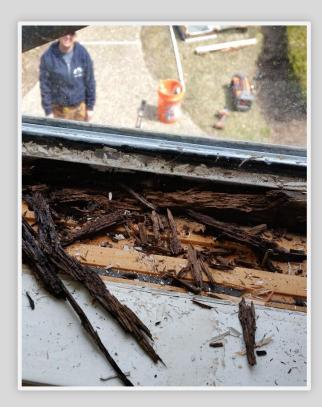
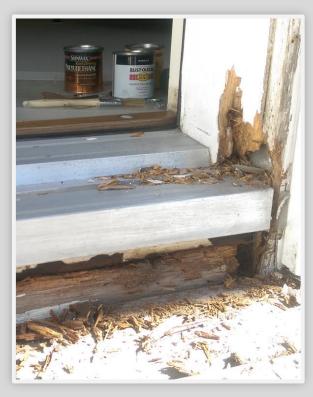
Over the years, **leaks have developed** causing severe interior damage

Window seals have dried up and crumbled

Window and door mechanisms have **corroded and rusted shut** due to the salt air

Nail heads securing the siding have **rusted away**

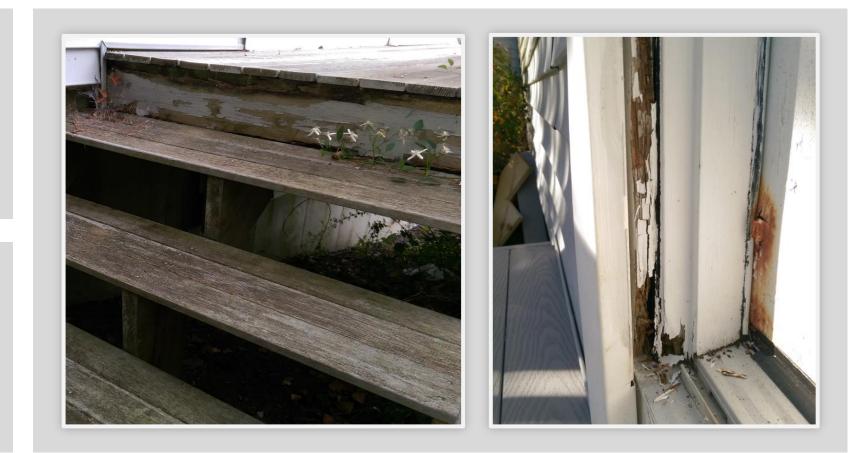
Wooden deck structures have deteriorated with age

Steel doors are constantly rusting

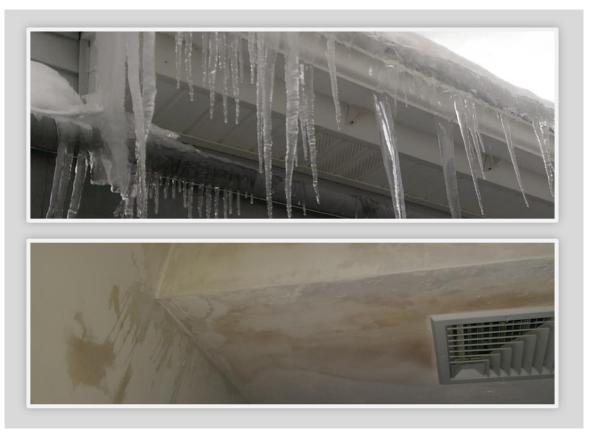
Ice dams are a constant cause of interior ceiling and wall damage

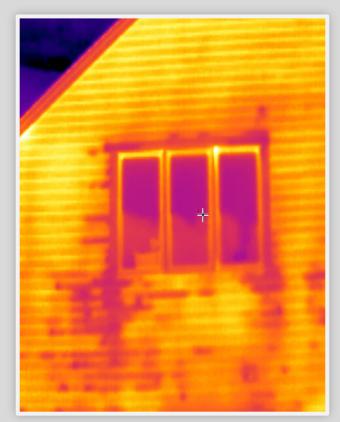
Potential failure (thermographic imagery)

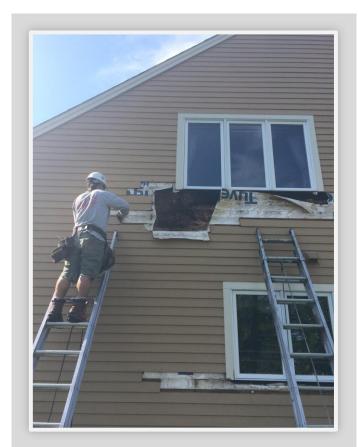
Verified envelope failure

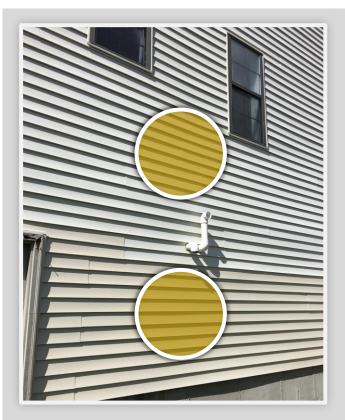
Previous repair performed, Note: different shades of vinyl siding.

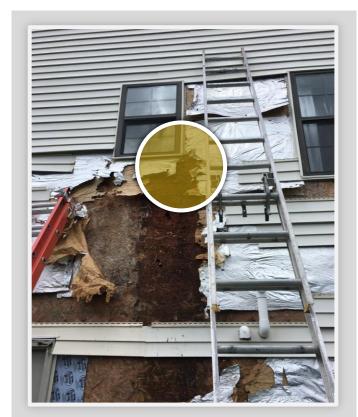
Major rot due to leaking window and lack of rough opening flashing.

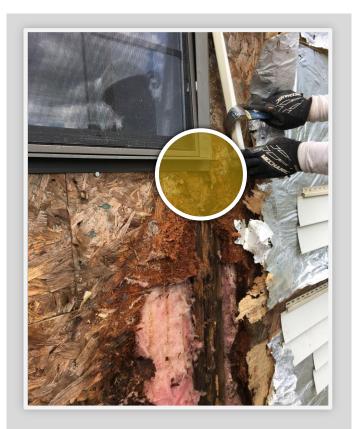
Resulting sheathing and framing rot due to lack of flashing at window.
